Analysis of a Clinically Failed, Mechanically Intact, Hemi-Toe Implant

Abstract - In this case study a clinically failed, mechanically intact, hemi-toe device was investigated. The clinical indication of the failure constitutes radiolucent line indicating loosening of the implant and possible interactions among the bone-implant initiated by osteolysis may become a factor, producing pain, inflammatory reactions, deformity and discomfort. The patient file was not available to determine these parameters. The device was titanium coated, Cobalt Chromium alloy used for making hemi-toe. Degeneration of hemi implant was due to spalling of the coating from the surface, causing loosening of stem from bone. However, pre-removal X-ray films were not available to confirm. Mechanism by which the clinical failure occurred likely due to lack of bony adhesion or other clinical reasons. Surface topographical features were documented using optical microscope. A method to classify various area of the articulating surface was proposed in this study that shows the anterior contacts were more damaging than the other areas where deeper scratches, pits and some debris were present. There is a need to conv

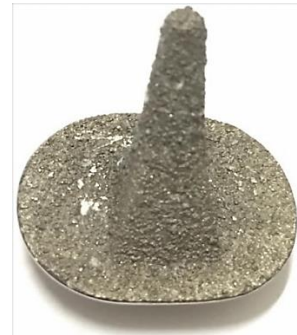
Scratches were visible on the shiny articulating surface of hemi-cap. There are also visible wear, spalling off of coating from the stem of the implant, Fig. 3. Visible sediments (white colored) on the stem and edges between stem and hemi-cap were notable. Since the stem was only presented for this investigation and liner was not available, the results and

Figure 3. Wear and spalling of coating materials from surface.

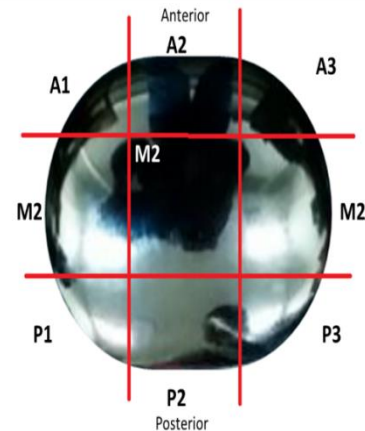
The convex articulating surface of the hemi-toe implant was divided into 9 segments. These regions are marked accordingly, Figure 4.

Figure 4. Nine segments marked on the articulating surface to assess damage.

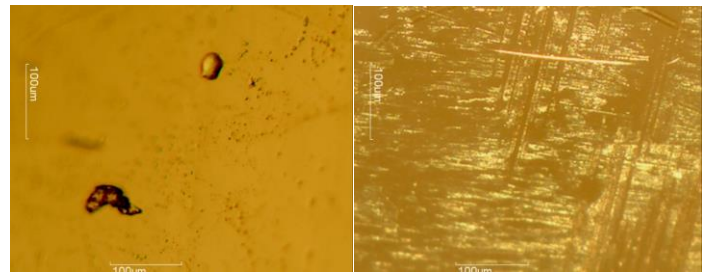
Figure 5. Optical microscope images at 40x shows pits and scratches in the middle regions.

The microscopy revealed that the anterior and middle section (Fig. 5-7) of the hemi experienced more scratches, wear and some debris deposition resulting from polymer debris and adhering to the surface may have occurred (3). Since the coating spalled (Fig. 3, 8) it may be possible that the device may have become loose. This loosening may have compromised the bony ingrowth and fixation of the device in the intramedullary canal of the bone. Since patient details are not available, it will not be possible to comment the time that this device was successful *in vivo*. The device maintained mechanical integrity though failed clinically because such fixations cause pain, deformity, infection and other potential problems (4).

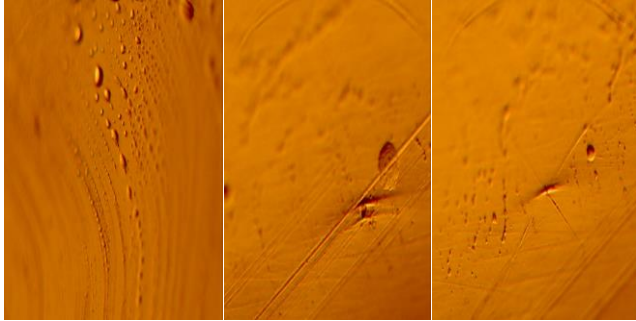
Figure 6. Optical microscope images on 40x magnification showing pits and scratches on the anterior and posterior regions where the hemi engages with liner A1, A2 and A3 regions.

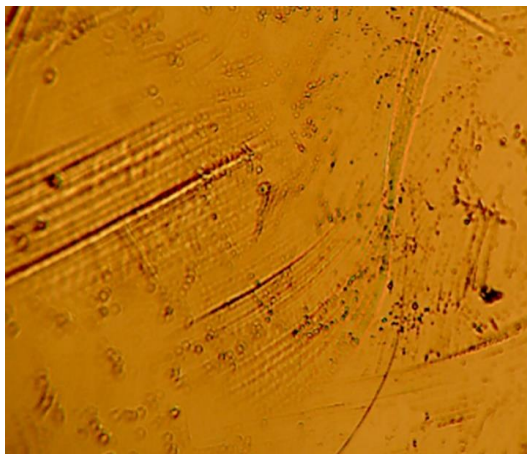
Figure 7. Optical microscope images at 40x showing pits, scratches on A3 region.

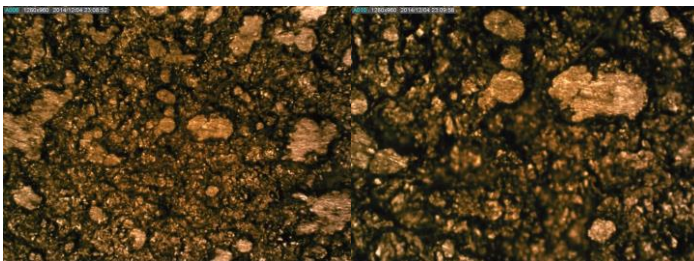
The coating on the surface of the stem was investigated. It appears that spherical beads were part of the coating system applied to the stem. The optical examination did not reveal biological matter in between the coating beads. Our experience has shown that biological matter builds in such areas, between the channels created by the beads.

Figure 8. Spherical pattern of the coat (x15 and x18).
