Analysis of a Clinically Failed, Mechanically Intact, Hemi-Toe Implant

Abstract - In this case study a clinically failed, mechanically intact, hemi-toe device was investigated. The clinical indication of the failure constitutes radiolucent line indicating loosening of the implant and possible interactions among the bone-implant initiated by osteolysis may become a factor, producing pain, inflammatory reactions, deformity and discomfort. The patient file was not available to determine these parameters. The device was titanium coated, Cobalt Chromium alloy used for making hemi-toe. Degeneration of hemi implant was due to spalling of the coating from the surface, causing loosening of stem from bone. However, pre-removal X-ray films were not available to confirm. Mechanism by which the clinical failure occurred likely due to lack of bony adhesion or other clinical reasons. Surface topographical features were documented using optical microscope. A method to classify various area of the articulating surface was proposed in this study that shows the anterior contacts were more damaging than the other areas where deeper scratches, pits and some debris were present. There is a need to conv

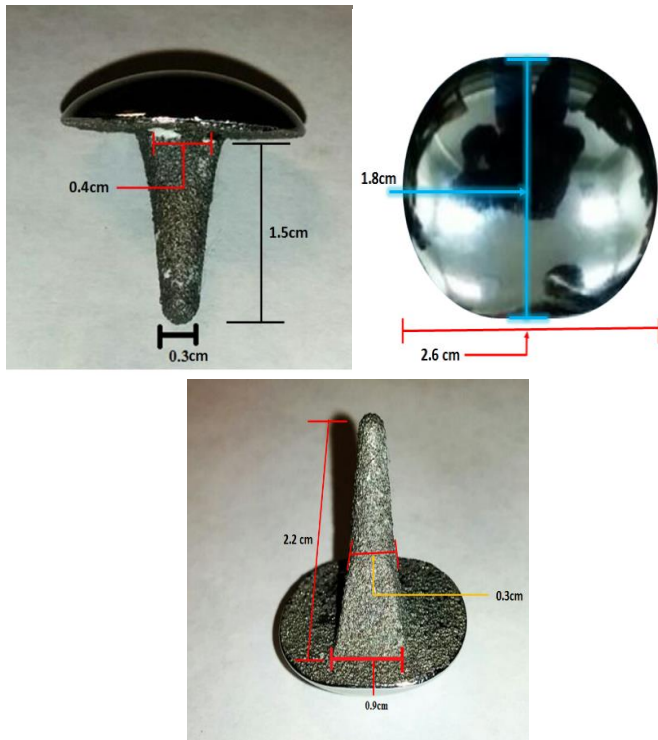
The dimensions of the hemi toe has been measured marked in Figure 2 (a), (b) and (c).

Figure 2. Device details from different angles, a) hemi-toe; b) posterior View of hemi-toe; c) bottom view of hemi-toe.
